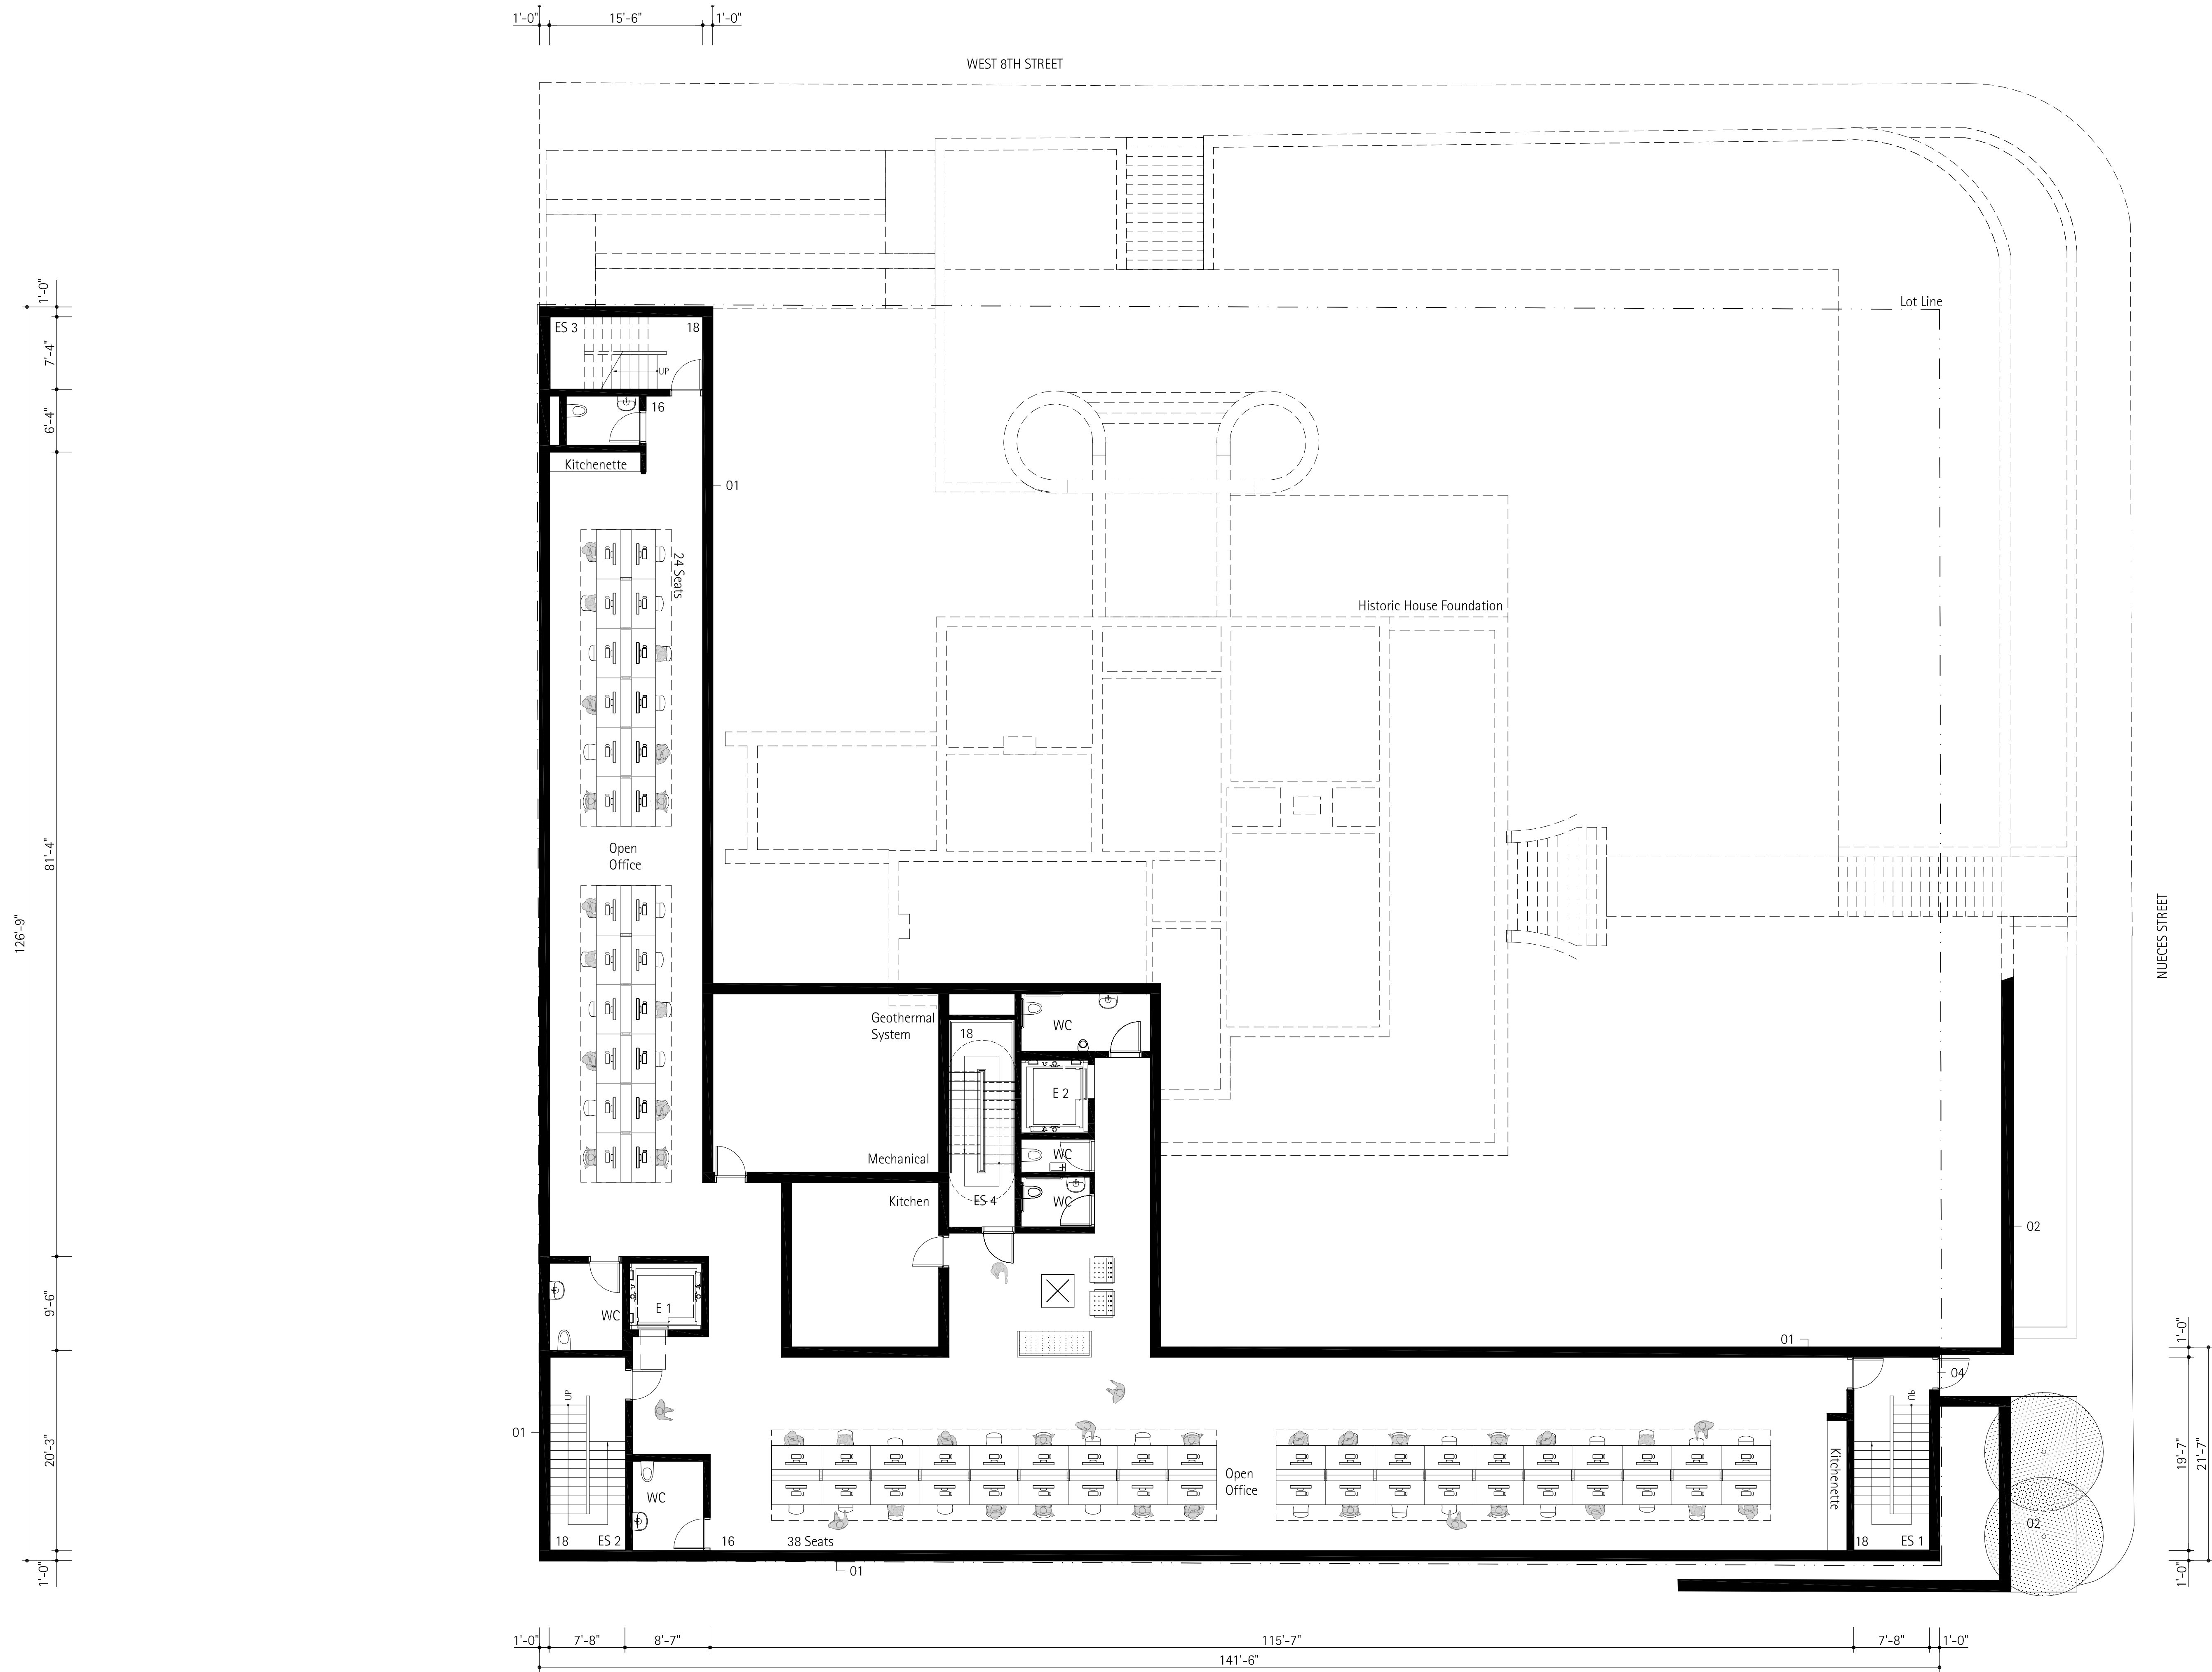
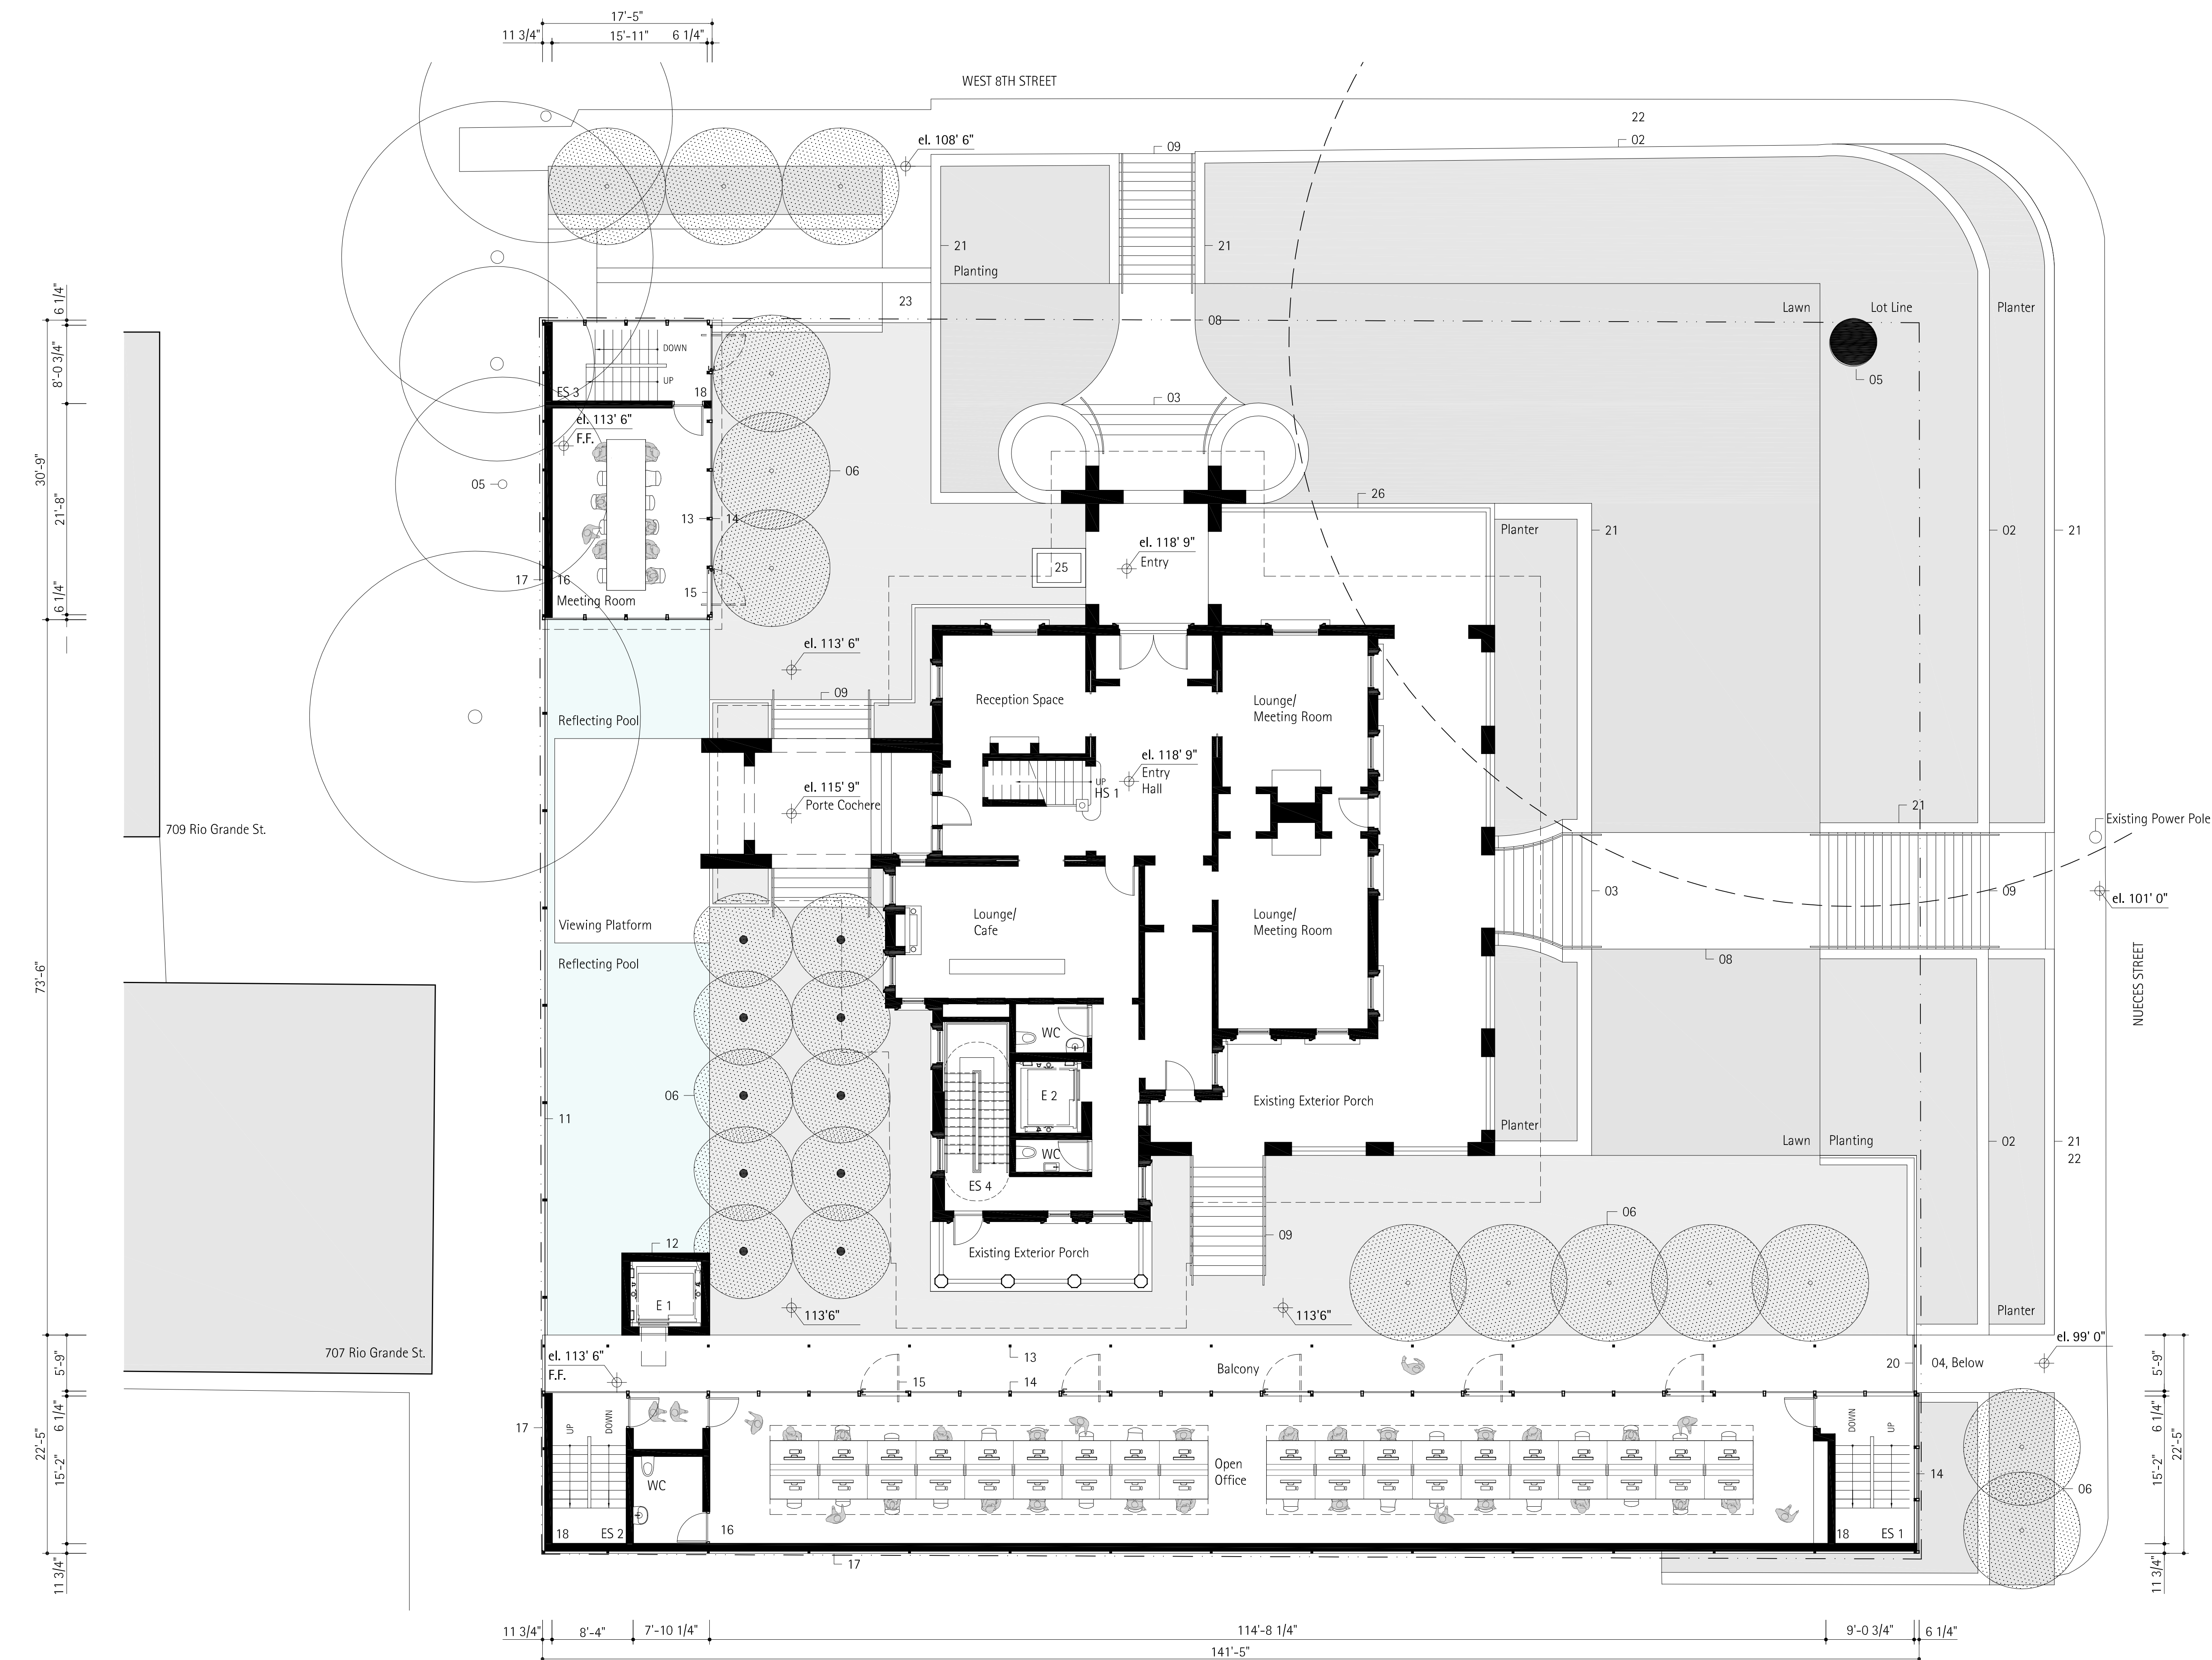
| Legend Notes | See Sheet A003 for Master Notes |
|---|---|
| 01 | New Concrete Foundation Wall |
| 02 | Existing Historic Site Wall to be Refurbished. |
| 03 | Existing Stairs to be Replaced with Code Compliant Stair with Solid Granite Block |
| 04 | Entrance to New Addition at Nueces Street |
| 05 | Historic Trees to Remain |
| 06 | New Trees |
| 07 | Historic Structure, See "H" Drawings for more Info. |
| 08 | Existing Pathway to be Removed and Replaced with Burnished Concrete |
| 09 | New Limestone Stair with New Stainless Steel Handrail |
| 10 | Existing Limit of Roof Eave |
| 11 | New White Painted Metal Panel Site Wall Sub-Structure to be 2Hr Rated Wall |
| 12 | Insulated Metal Panel on Concrete Elevator Shaft |
| 13 | Painted Steel Structure |
| 14 | Insulated Glass Unit Window System |
| 15 | Insulated Glass Unit Door System |
| 16 | Raised Floor on Exposed Steel Framing |
| 17 | White Painted Metal Panel on Steel Stud Framing |
| 18 | Painted, Tread and Riser, Stair |
| 19 | Fully Adhered PVC Roof Membrane |
| 20 | Stainless Steel Wire Mesh Guardrail |
| 21 | New Site Retaining Wall |
| 22 | New Sidewalk |
| 23 | New ADA Ramp |
| 24 | Elevator Bulk Head |
| 25 | ADA Platform Lift |
| 26 | New Historic Balustrade |

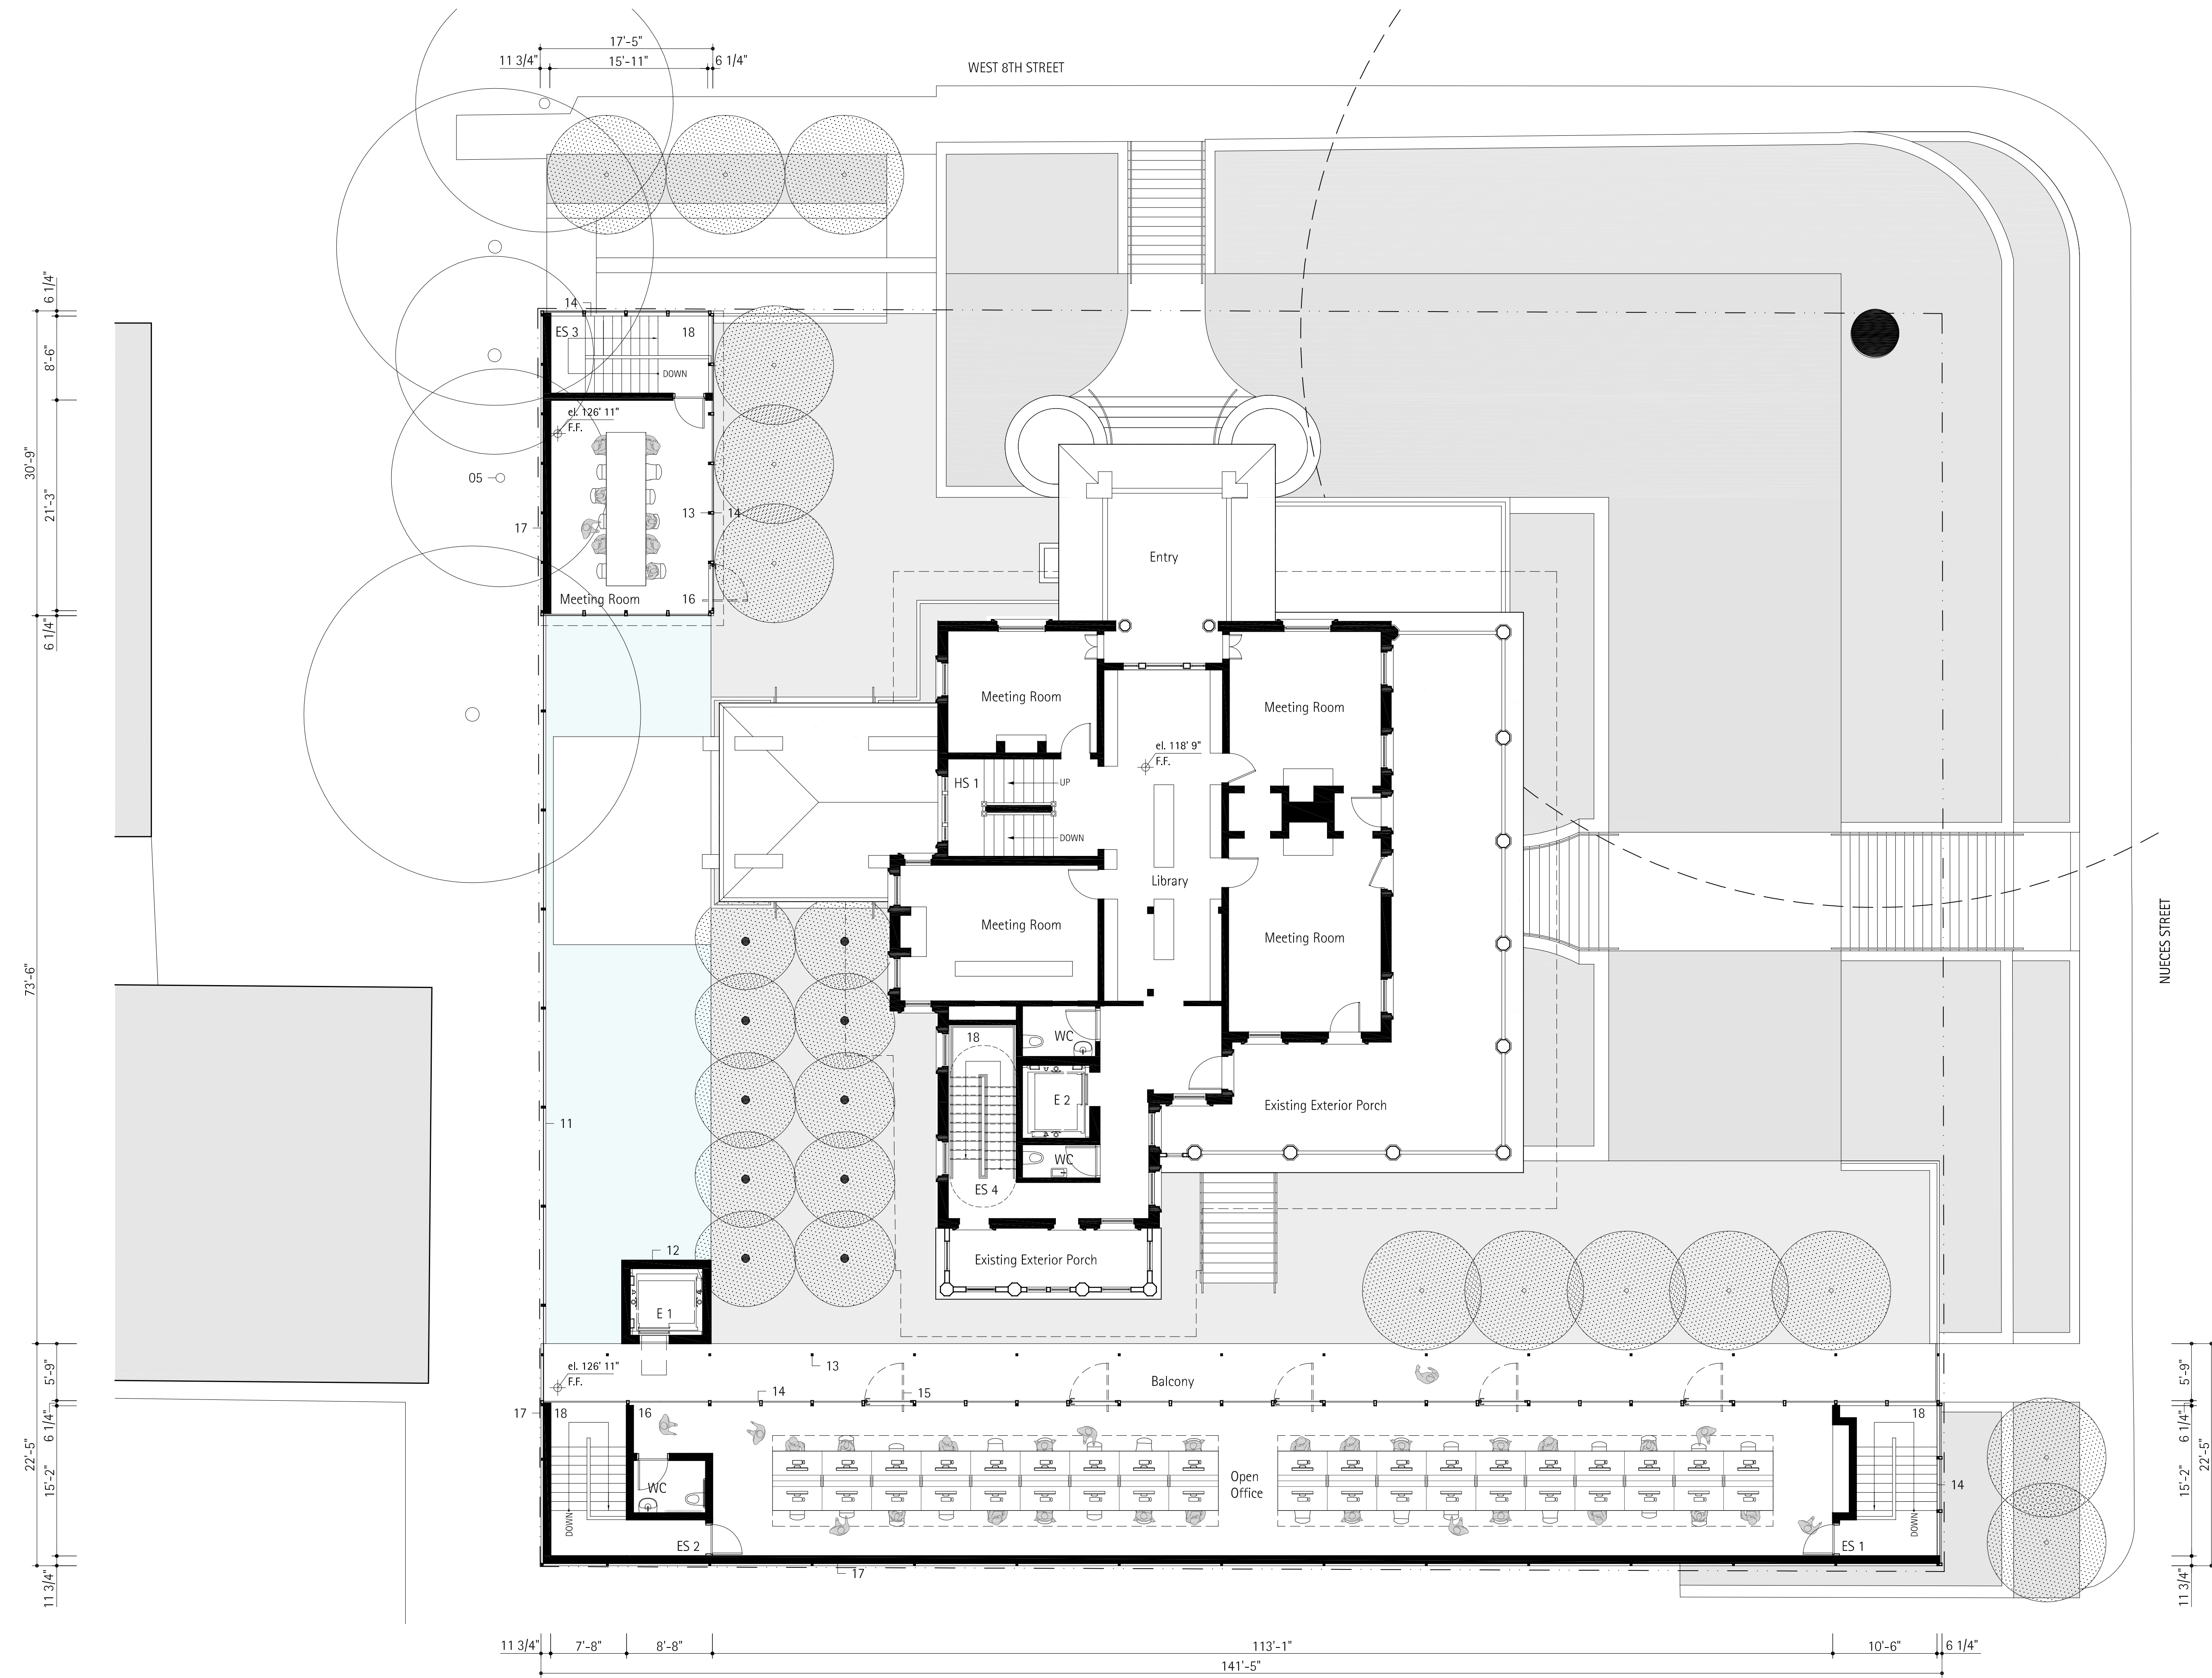
- 01 New Concrete Foundation Wall
- 02 Existing Historic Site Wall to be Refurbished.
- 03 Existing Stairs to be Replaced with Code Compliant Stair with Solid Granite Block

- 04 Entrance to New Addition at Nueces Street
- 05 Historic Trees to Remain
- 06 New Trees
- 07 Historic Structure, See "H" Drawings for more Info.
- 08 Existing Pathway to be Removed and Replaced with Burnished Concrete

- 09 New Limestone Stair with New Stainless Steel Handrail
- 10 Existing Limit of Roof Eave
- 11 New White Painted Metal Panel Site Wall Sub-Structure to be 2Hr Rated Wall

- 12 Insulated Metal Panel on Concrete Elevator Shaft
- 13 Painted Steel Structure
- 14 Insulated Glass Unit Window System
- 15 Insulated Glass Unit Door System

- 16 Raised Floor on Exposed Steel Framing
- 17 White Painted Metal Panel on Steel Stud Framing
- 18 Painted, Tread and Riser, Stair
- 19 Fully Adhrered PVC Roof Membrane

- 20 Stainless Steel Wire Mesh Guardrail
- 21 New Site Retaining Wall
- 22 New Sidewalk
- 23 New ADA Ramp
- 24 Elevator Bulk Head
- 25 ADA Platform Lift
- 26 New Historic Balustrade

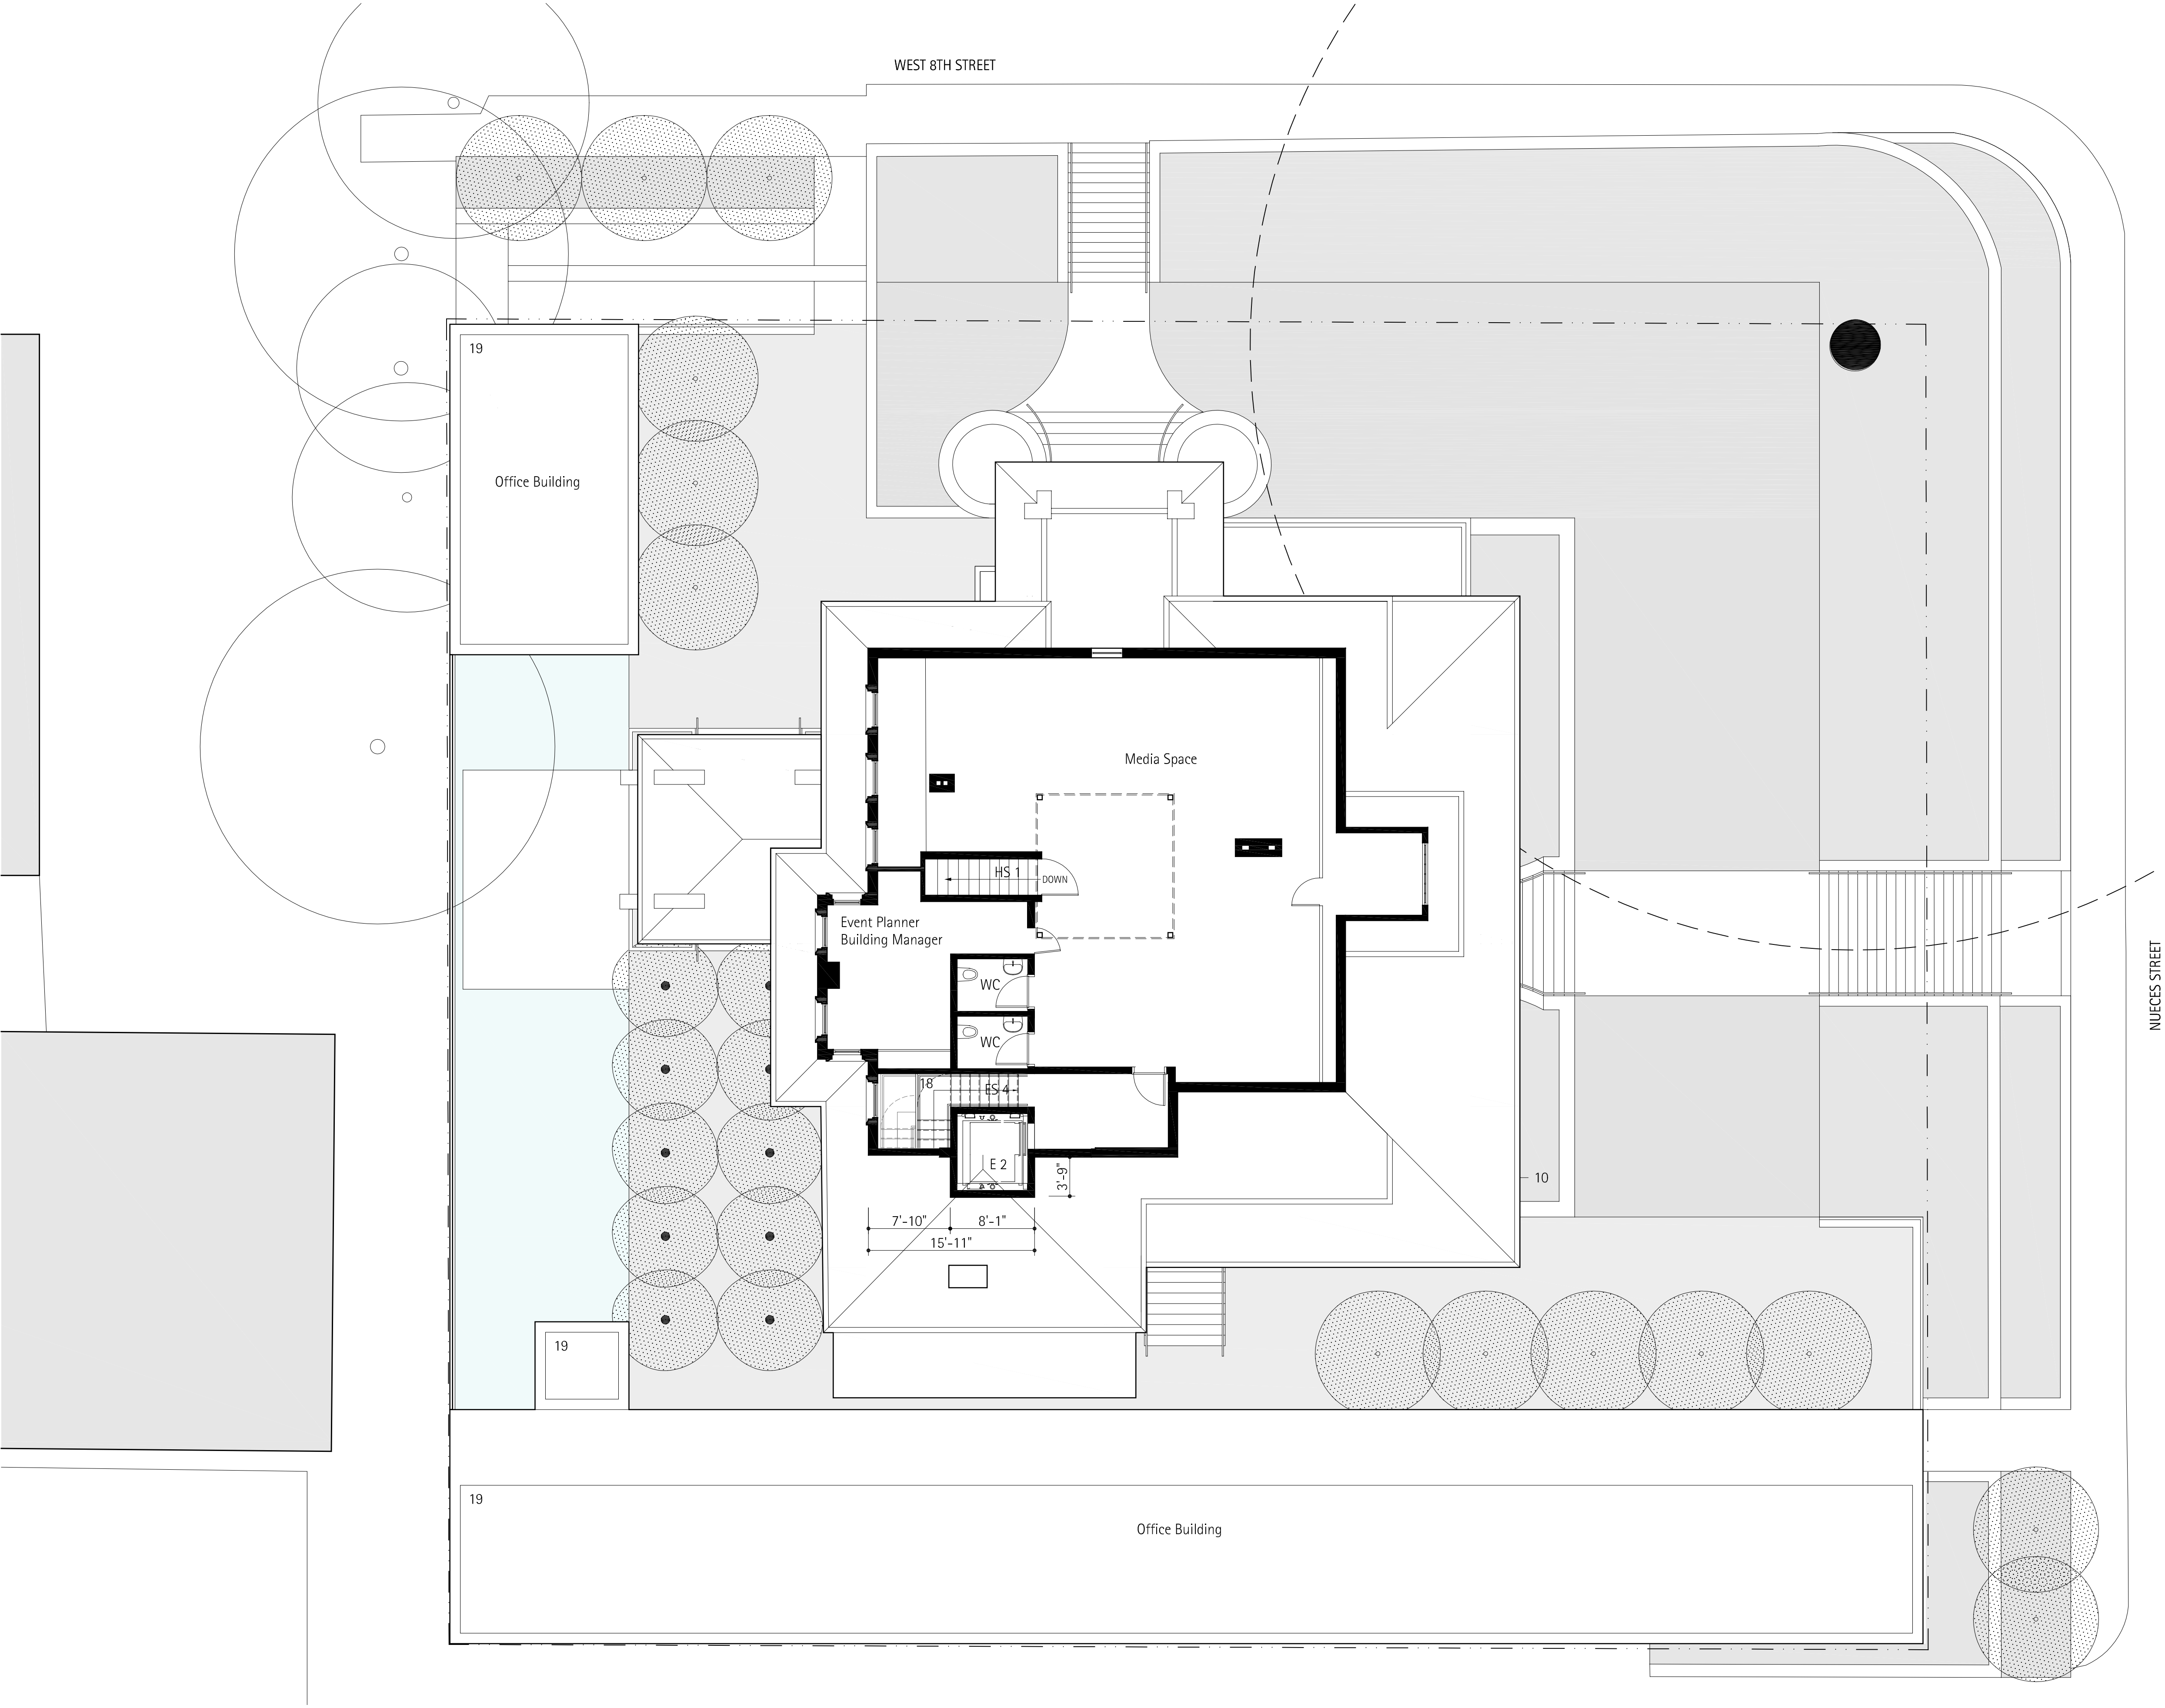
- 01 New Concrete Foundation Wall
- 02 Existing Historic Site Wall to be Refurbished.
- 03 Existing Stairs to be Replaced with Code Compliant Stair with Solid Granite Block

- 04 Entrance to New Addition at Nueces Street
- 05 Historic Trees to Remain
- 06 New Trees
- 07 Historic Structure, See "H" Drawings for more Info.
- 08 Existing Pathway to be Removed and Replaced with Burnished Concrete

- 09 New Limestone Stair with New Stainless Steel Handrail
- 10 Existing Limit of Roof Eave
- 11 New White Painted Metal Panel Site Wall Sub-Structure to be 2Hr Rated Wall

- 12 Insulated Metal Panel on Concrete Elevator Shaft
- 13 Painted Steel Structure
- 14 Insulated Glass Unit Window System
- 15 Insulated Glass Unit Door System

- 16 Raised Floor on Exposed Steel Framing
- 17 White Painted Metal Panel on Steel Stud Framing
- 18 Painted, Tread and Riser, Stair
- 19 Fully Adhrered PVC Roof Membrane

- 20 Stainless Steel Wire Mesh Guardrail
- 21 New Site Retaining Wall
- 22 New Sidewalk
- 23 New ADA Ramp
- 24 Elevator Bulk Head
- 25 ADA Platform Lift
- 26 New Historic Balustrade

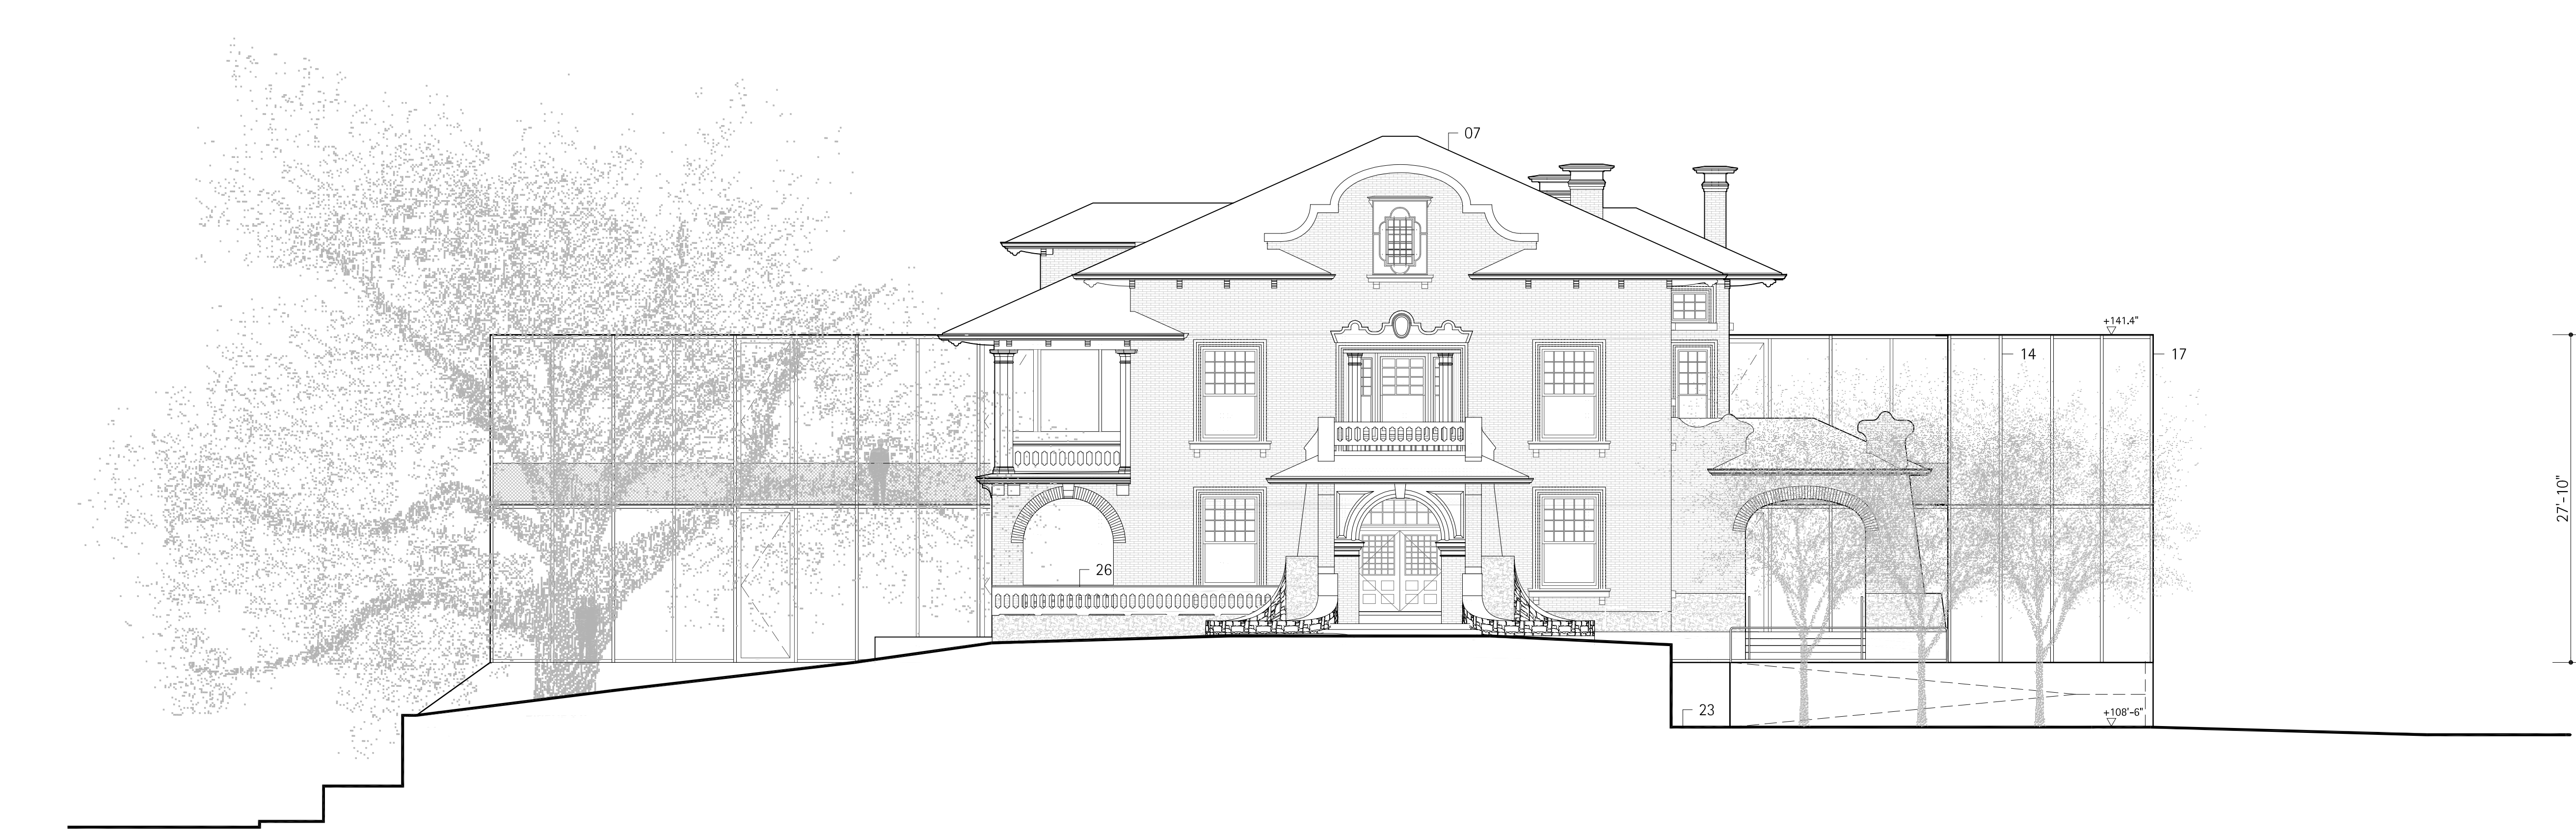
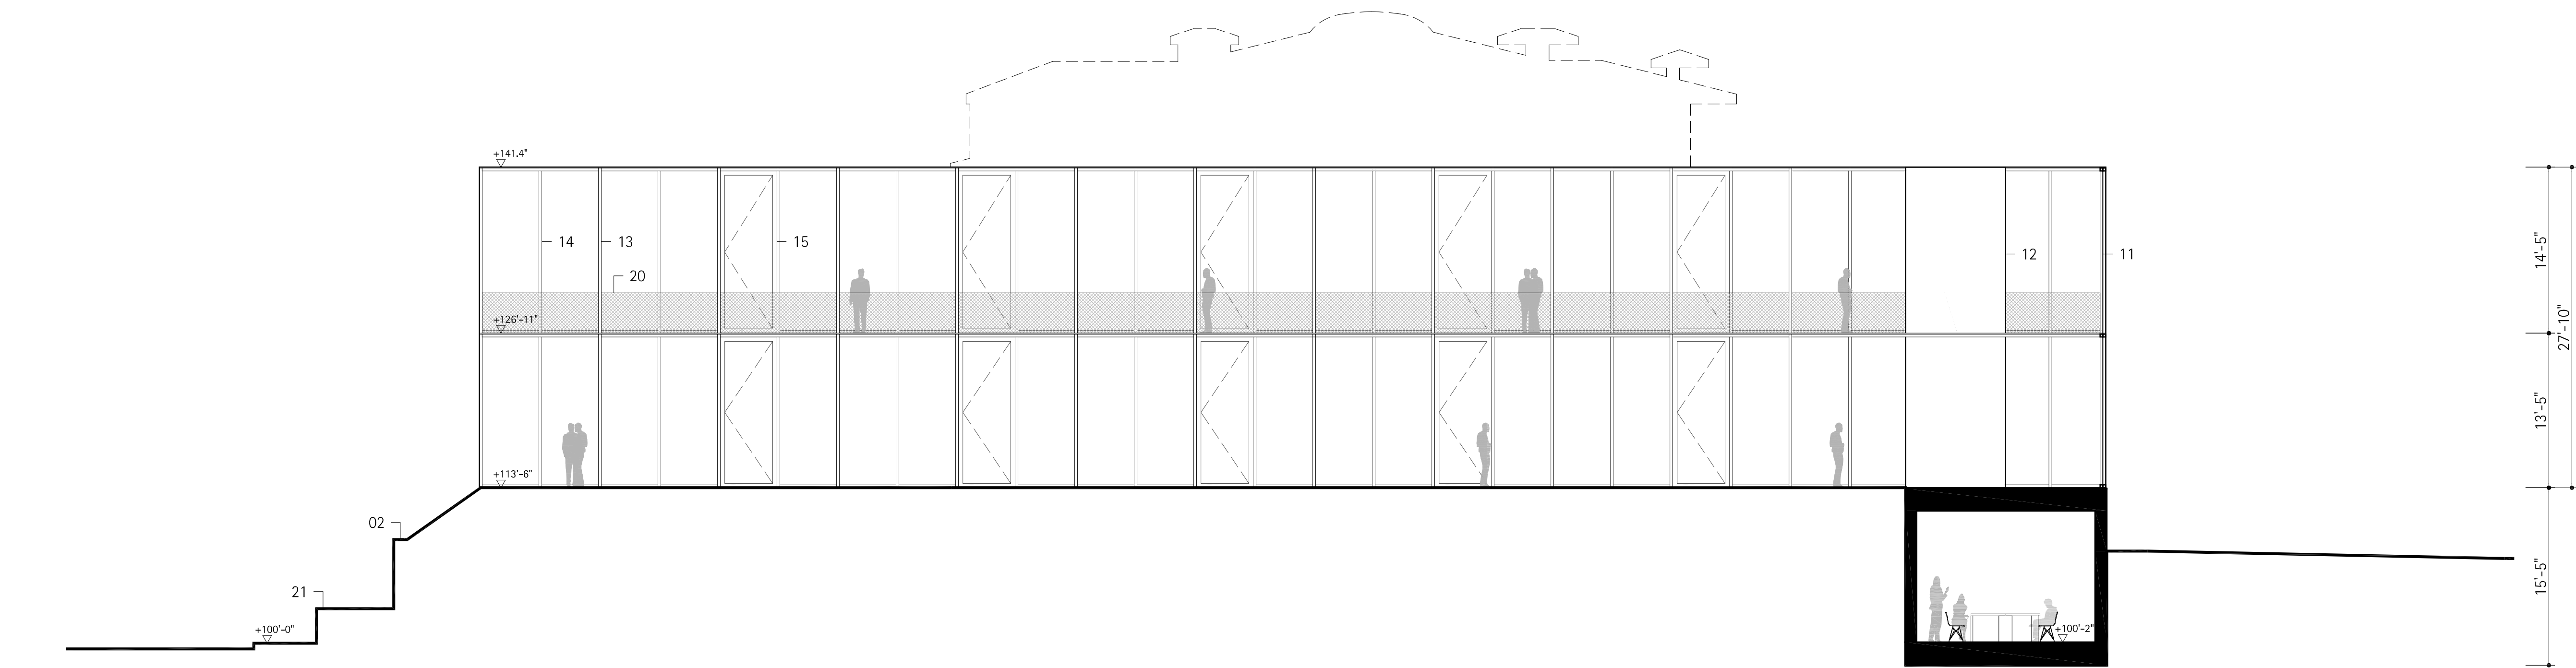
| Legend Notes | | See Sheet A003 for Master Notes |
|---|---|---|
| 01 | New Concrete Foundation Wall | |
| 02 | Existing Historic Site Wall to be Refurbished. | |
| 03 | Existing Stairs to be Replaced with Code Compliant Stair with Solid Granite Block | |
| 04 | Entrance to New Addition at Nueces Street | |
| 05 | Historic Trees to Remain | |
| 06 | New Trees | |
| 07 | Historic Structure, See "H" Drawings for more Info. | |
| 08 | Existing Pathway to be Removed and Replaced with Burnished Concrete | |
| 09 | New Limestone Stair with New Stainless Steel Handrail | |
| 10 | Existing Limit of Roof Eave | |
| 11 | New White Painted Metal Panel Site Wall Sub-Structure to be 2Hr Rated Wall | |
| 12 | Insulated Metal Panel on Concrete Elevator Shaft | |
| 13 | Painted Steel Structure | |
| 14 | Insulated Glass Unit Window System | |
| 15 | Insulated Glass Unit Door System | |
| 16 | Raised Floor on Exposed Steel Framing | |
| 17 | White Painted Metal Panel on Steel Stud Framing | |
| 18 | Painted, Tread and Riser, Stair | |
| 19 | Fully Adhrered PVC Roof Membrane | |
| 20 | Stainless Steel Wire Mesh Guardrail | |
| 21 | New Site Retaining Wall | |
| 22 | New Sidewalk | |
| 23 | New ADA Ramp | |
| 24 | Elevator Bulk Head | |
| 25 | ADA Platform Lift | |
| 26 | New Historic Balustrade | |
